**Flood Control Project Maintenance
Levee Inspections****LMA District Cover Sheet****Spring 2011 Levee Inspection Results****San Joaquin County Flood Control and Water Conservation District**

Spring 2011 Levee Inspection Results

San Joaquin County Flood Control and Water Conservation District

Waterway			Bank	Unit Miles
Unit No. 01 Littlejohn Creek			Left	2.87

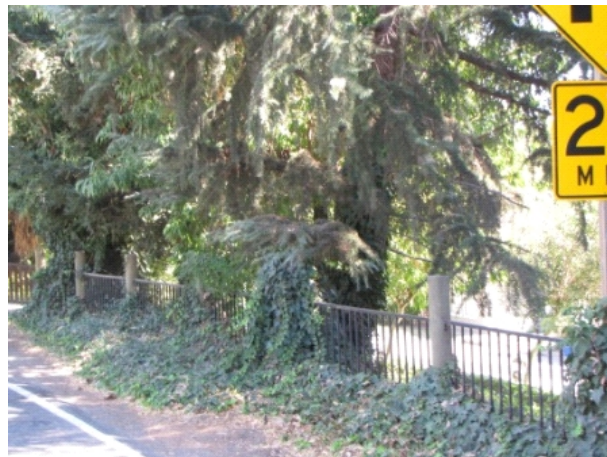
Levee Mile Report Line	169
Start Levee Mile	22.17
End Levee Mile	22.18
Location	Land Side
Category	Earthen Levee
Item	Encroachments

View of a fence and landscaping along the landward shoulder and slope looking upstream.

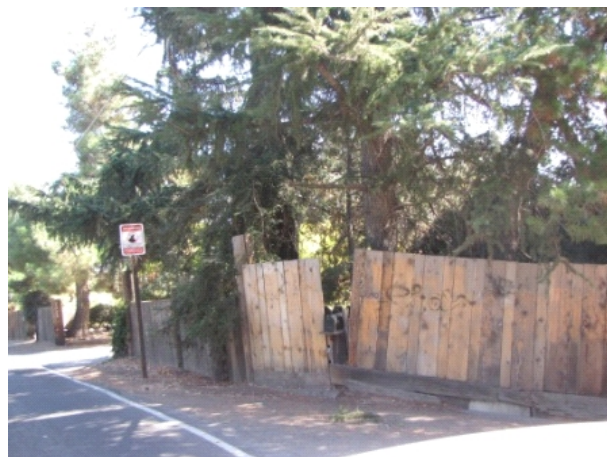
Levee Mile Report Line	171
Start Levee Mile	22.19
End Levee Mile	22.21
Location	Land Side
Category	Earthen Levee
Item	Encroachments

View of a fence along the landward shoulder and slope looking upstream.

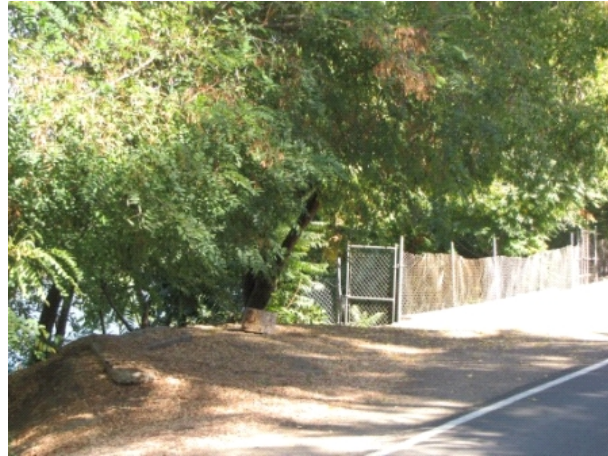
View of a fence along the waterward shoulder and slope looking upstream.

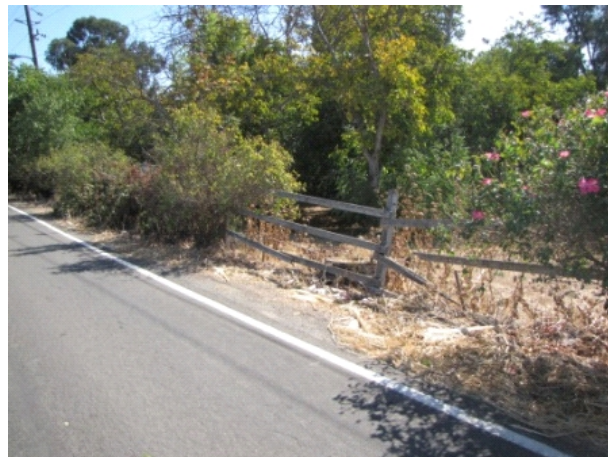
Levee Mile Report Line	174
Start Levee Mile	22.26
End Levee Mile	22.30
Location	Land Side
Category	Earthen Levee
Item	Encroachments

View of a fence along the landward shoulder looking upstream.

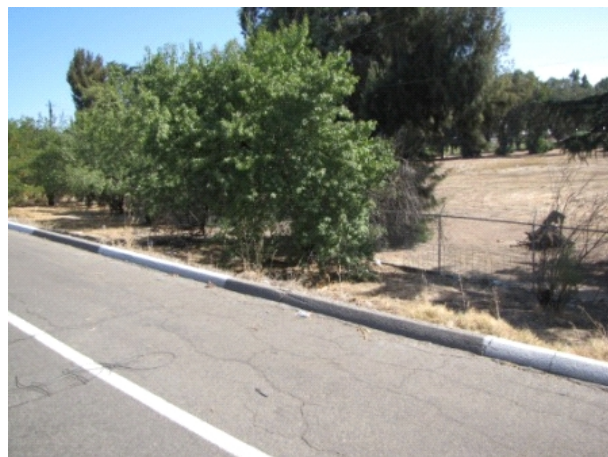
Levee Mile Report Line	177
Start Levee Mile	22.37
End Levee Mile	22.43
Location	Land Side
Category	Earthen Levee
Item	Encroachments

View of fence and landscaping along landward slope looking upstream.

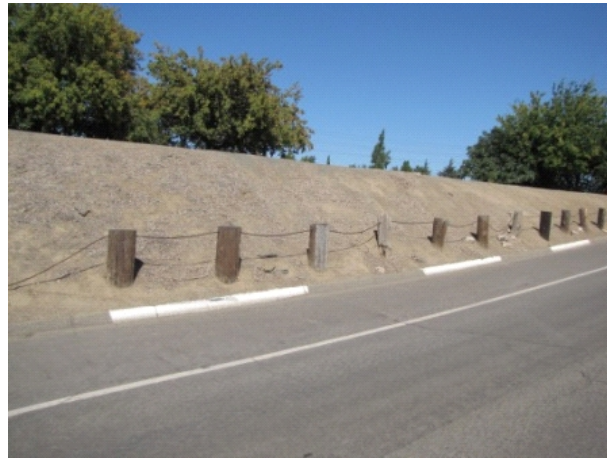
View of a post and cable fence along the landward slope looking upstream.

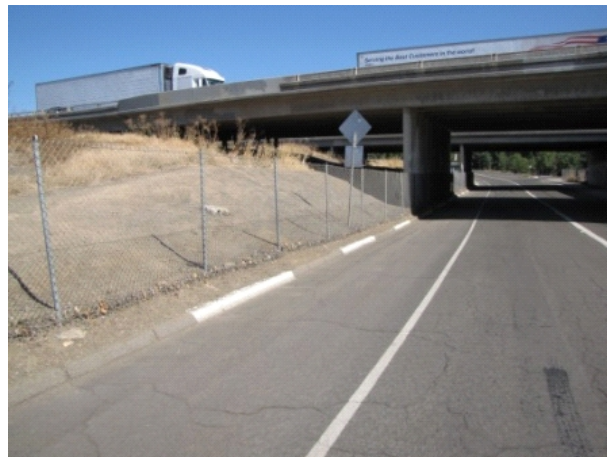
Levee Mile Report Line	179
Start Levee Mile	22.46
End Levee Mile	22.52
Location	Land Side
Category	Earthen Levee
Item	Encroachments

View of fence along landward toe looking upstream.

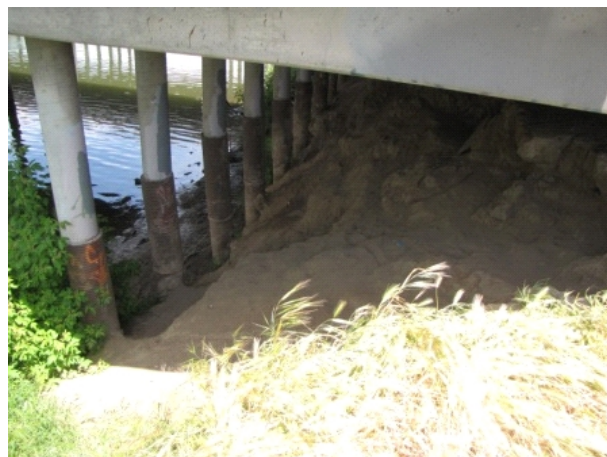
Levee Mile Report Line	180
Start Levee Mile	22.52
End Levee Mile	22.52
Location	Water Side
Category	Earthen Levee
Item	Slope Stability

View of slope instability on the waterward slope under I-5 looking upstream.

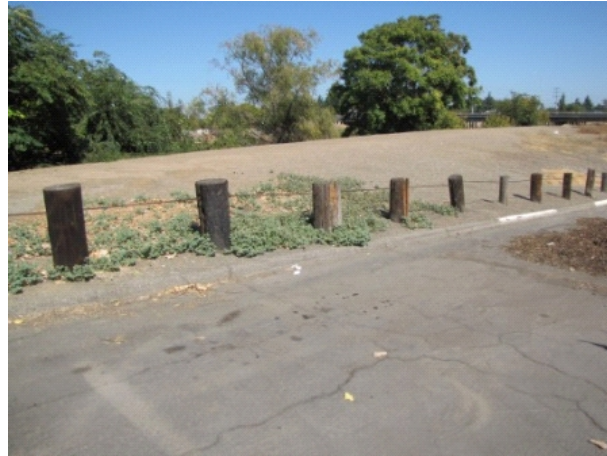
View of post and cable fence along the landward levee slope looking upstream.

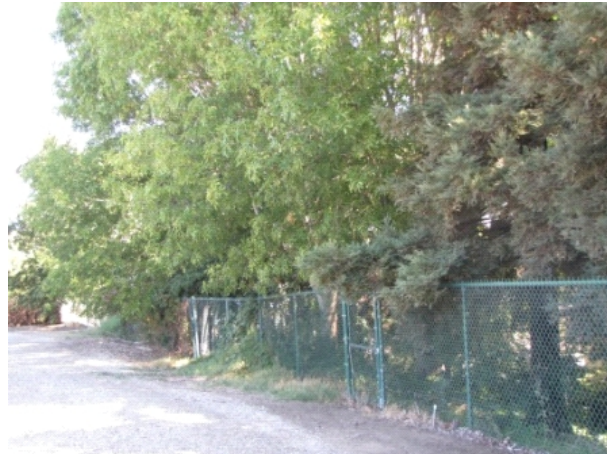
Levee Mile Report Line	184
Start Levee Mile	22.58
End Levee Mile	22.87
Location	Land Side
Category	Earthen Levee
Item	Encroachments

View of fence and landscaping along the landward shoulder and slope looking upstream.

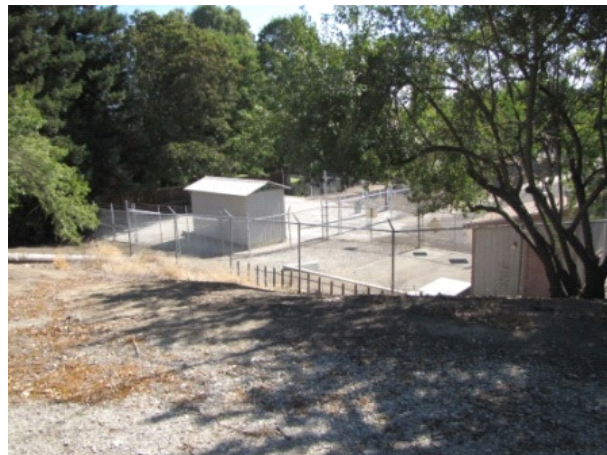
Levee Mile Report Line	189
Start Levee Mile	22.87
End Levee Mile	22.89
Location	Land Side
Category	Earthen Levee
Item	Encroachments

View of fence along the landward slope.

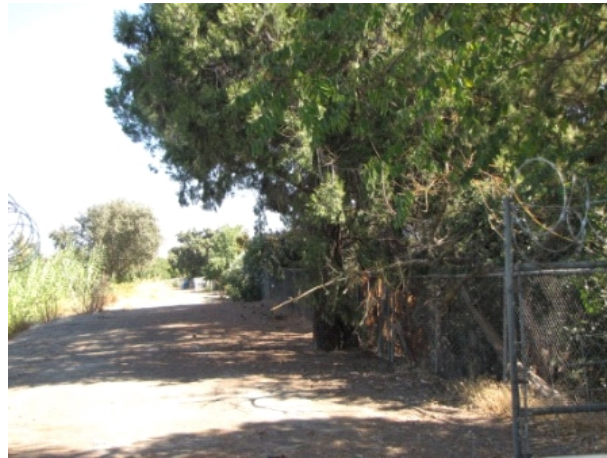
View of fence and landscaping along the landward shoulder looking upstream.

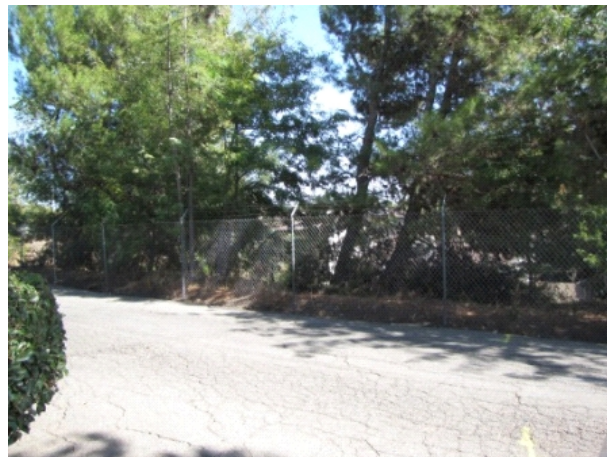
pkazi_s_20110328_302.jpg

View of fence along the landward shoulder looking upstream.

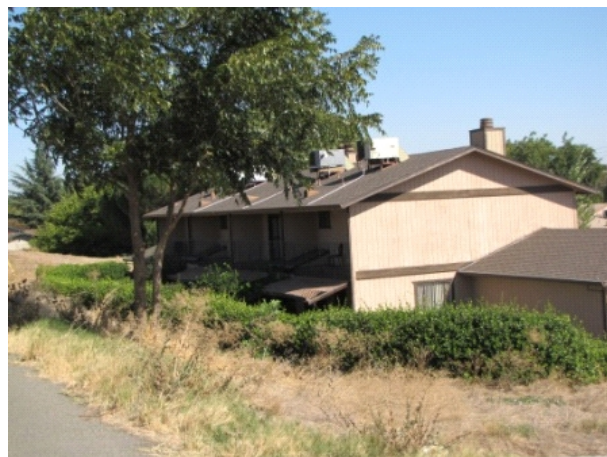
pkazi_s_20110328_301.jpg

Levee Mile Report Line	196
Start Levee Mile	23.24
End Levee Mile	23.27
Location	Land Side
Category	Earthen Levee
Item	Encroachments

View of landscaping along the landward slope looking upstream.

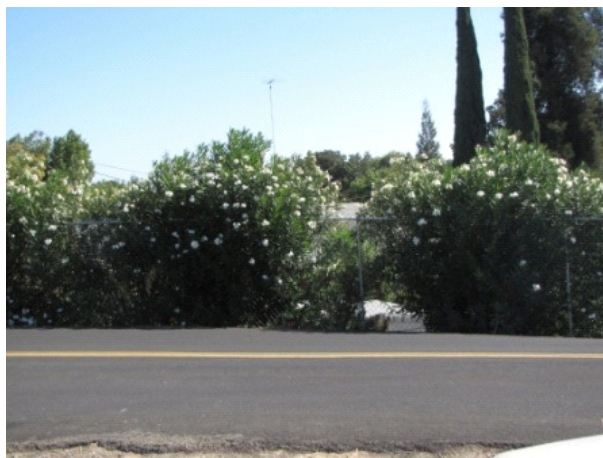
pkazi_s_20110328_299.jpg

View of fence and landscaping along the landward slope.

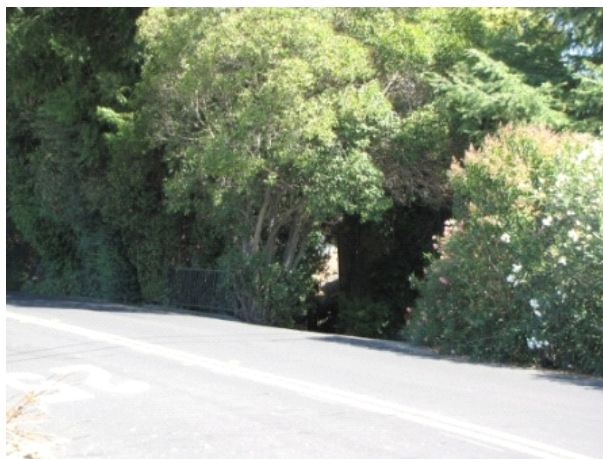
pkazi_s_20110328_300.jpg

Levee Mile Report Line	198
Start Levee Mile	23.30
End Levee Mile	23.34
Location	Land Side
Category	Earthen Levee
Item	Encroachments

View of landscaping along the landward levee slope looking upstream.

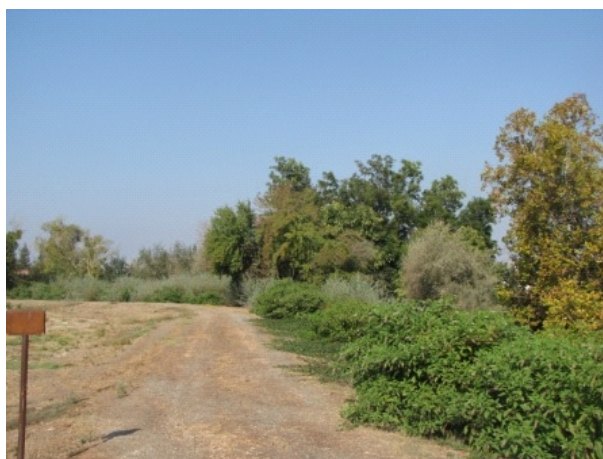
pkazi_s_20110328_348.jpg

Levee Mile Report Line	199
Start Levee Mile	23.70
End Levee Mile	23.70
Location	Water Side
Category	Earthen Levee
Item	Encroachments

View of vegetation along the waterward slope looking downstream.

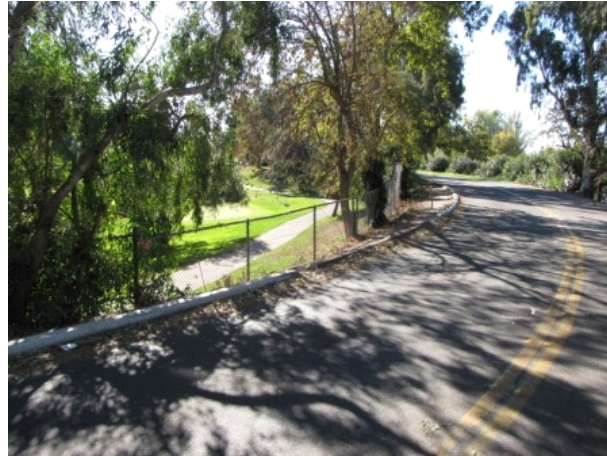
pkazi_s_20110328_347.jpg

View of the fence along the landward slope looking downstream.

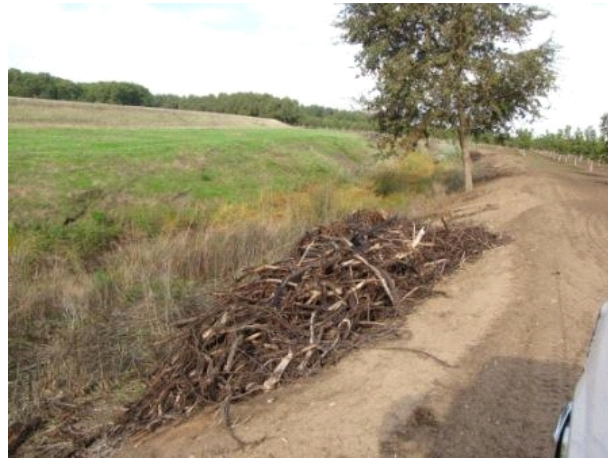
pkazi_s_20110328_350.jpg

View of a prunings pile along the waterward bank looking downstream.

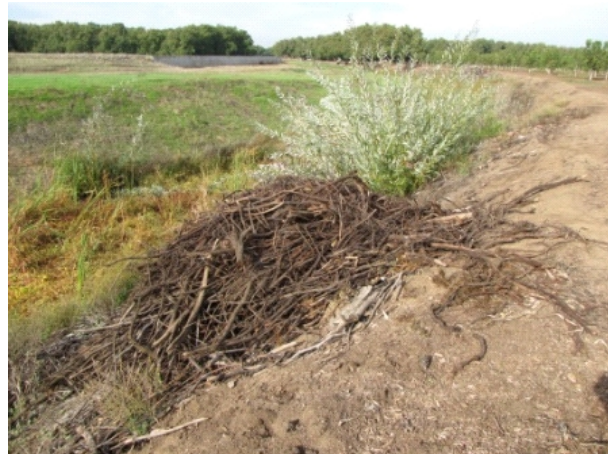
pkazi_s_20110328_351.jpg

Levee Mile Report Line	2
Start Levee Mile	0.17
End Levee Mile	0.17
Location	Water Side
Category	Earthen Levee
Item	Encroachments

View of a prunings pile along the waterward bank looking downstream.

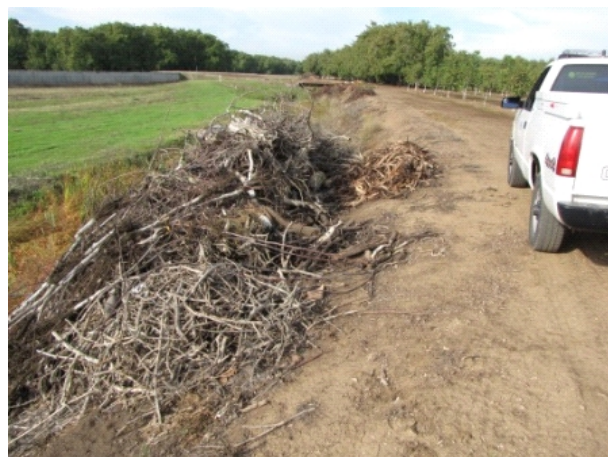
pkazi_s_20110328_352.jpg

Levee Mile Report Line	3
Start Levee Mile	0.22
End Levee Mile	0.22
Location	Water Side
Category	Earthen Levee
Item	Encroachments

View of a prunings pile along the waterward bank looking downstream.

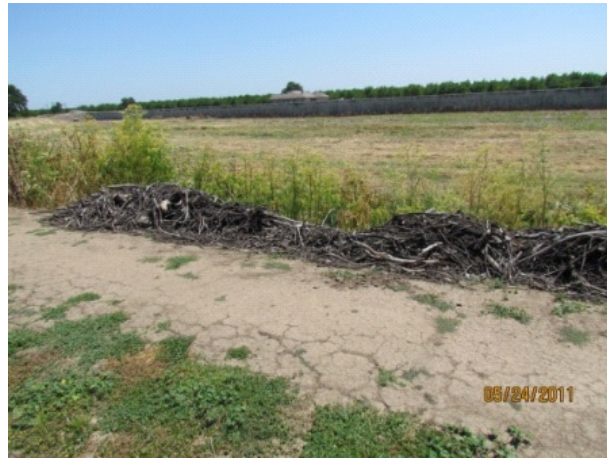
pkazi_s_20110526_607.jpg

Pruning was found on the waterside of the levee. The picture was taken from the crown looking upstream.

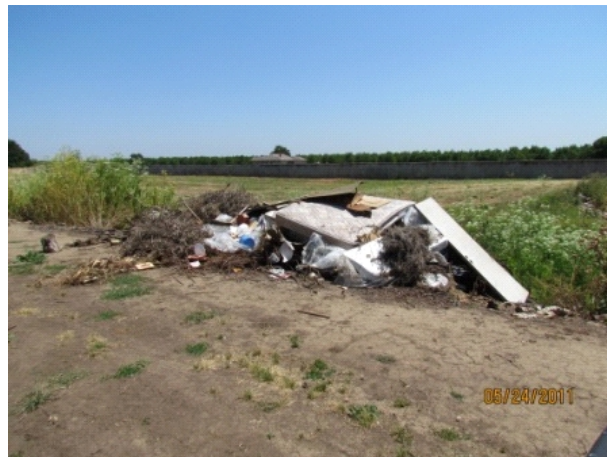
pkazi_s_20110526_606.jpg

Levee Mile Report Line	7
Start Levee Mile	0.28
End Levee Mile	0.28
Location	Water Side
Category	Earthen Levee
Item	Encroachments

Garbage on the waterside of the levee looking upstream.

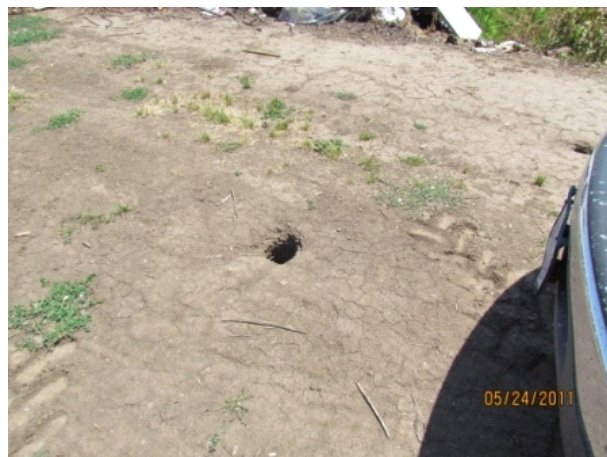
pkazi_s_20110526_605.jpg

Levee Mile Report Line	8
Start Levee Mile	0.28
End Levee Mile	0.28
Location	Crown
Category	Earthen Levee
Item	Animal Control

A rodent hole was found on the crown of the levee. The picture was taken from the crown looking upstream.

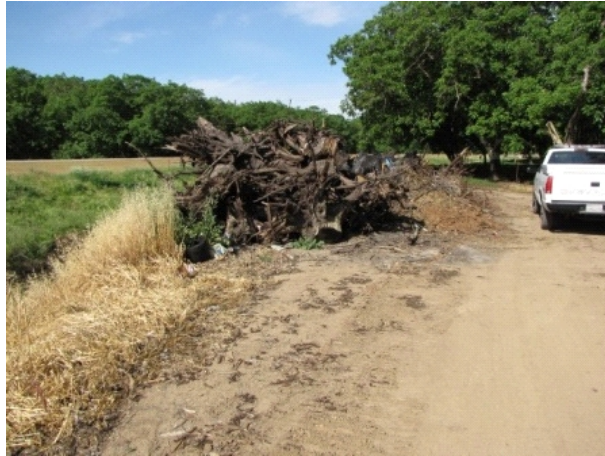
9	0.37	0.37	Earthen Levee	Encroachments	WS	M	Debris Inspector Comments: Pile appears to be the same pile as last year and has not been burned.	37.958565 ° -121.154819 °	37.958565 ° -121.154819 °	1 Y

Levee Mile Report Line	9
Start Levee Mile	0.37
End Levee Mile	0.37
Location	Water Side
Category	Earthen Levee
Item	Encroachments
Debris pile located on waterside of levee at LM 0.50.	
pkazi_s_20110328_349.jpg

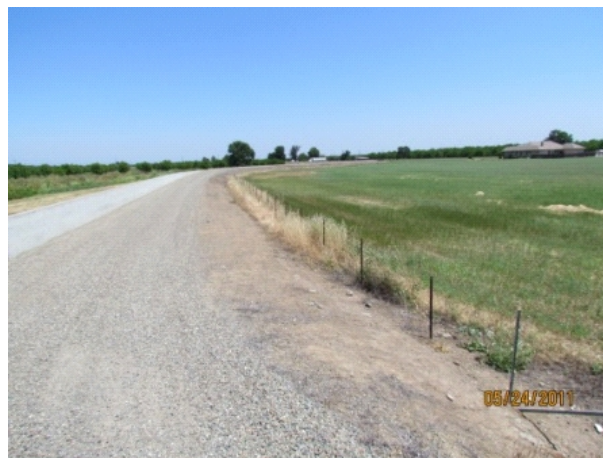
pkazi_s_20110526_612.jpg

Fences along the landside toe of the levee. The picture was taken from the crown looking upstream.

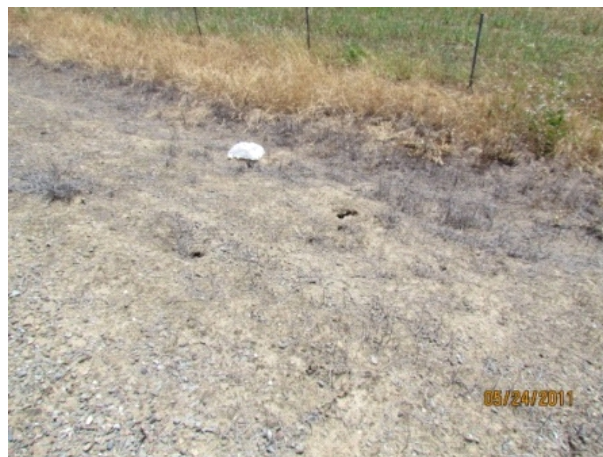
pkazi_s_20110526_610.jpg

Levee Mile Report Line	2
Start Levee Mile	0.20
End Levee Mile	0.20
Location	Land Side
Category	Earthen Levee
Item	Animal Control

Rodent holes were found on the landside of the levee. The picture was taken from the crown looking toward landside.

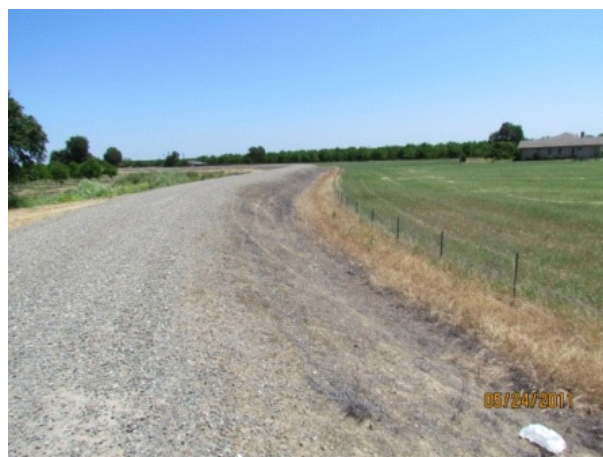
pkazi_s_20110526_609.jpg

Levee Mile Report Line	3
Start Levee Mile	0.20
End Levee Mile	0.20
Location	Land Side
Category	Earthen Levee
Item	Vegetation

Vegetation complied with the standards on the landside of the levee. The picture was taken from the crown looking upstream.

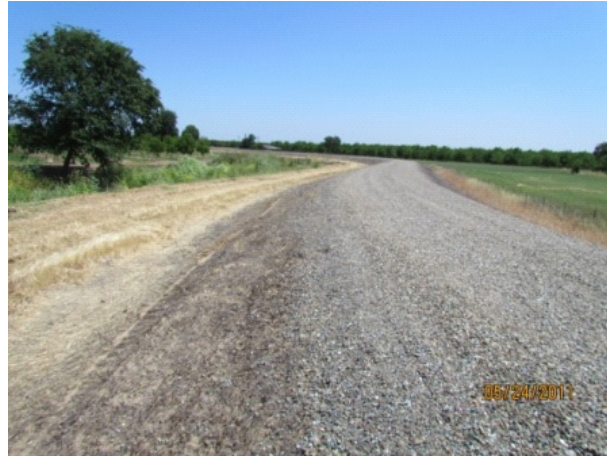
Levee Mile Report Line	4
Start Levee Mile	0.20
End Levee Mile	0.20
Location	Water Side
Category	Earthen Levee
Item	Vegetation
Vegetation complies with the standards on the waterside of the levee. The picture was taken from the crown looking upstream.	
pkazi_s_20110526_611.jpg
